Home Inspection Report by *J & D Inspections Inc.*

Date: 1/01/2007
Dwelling Address: 12345 Your Street, Denver, CO
Client Name: Happy & Informed Couple
Client's Agent: Your Agent

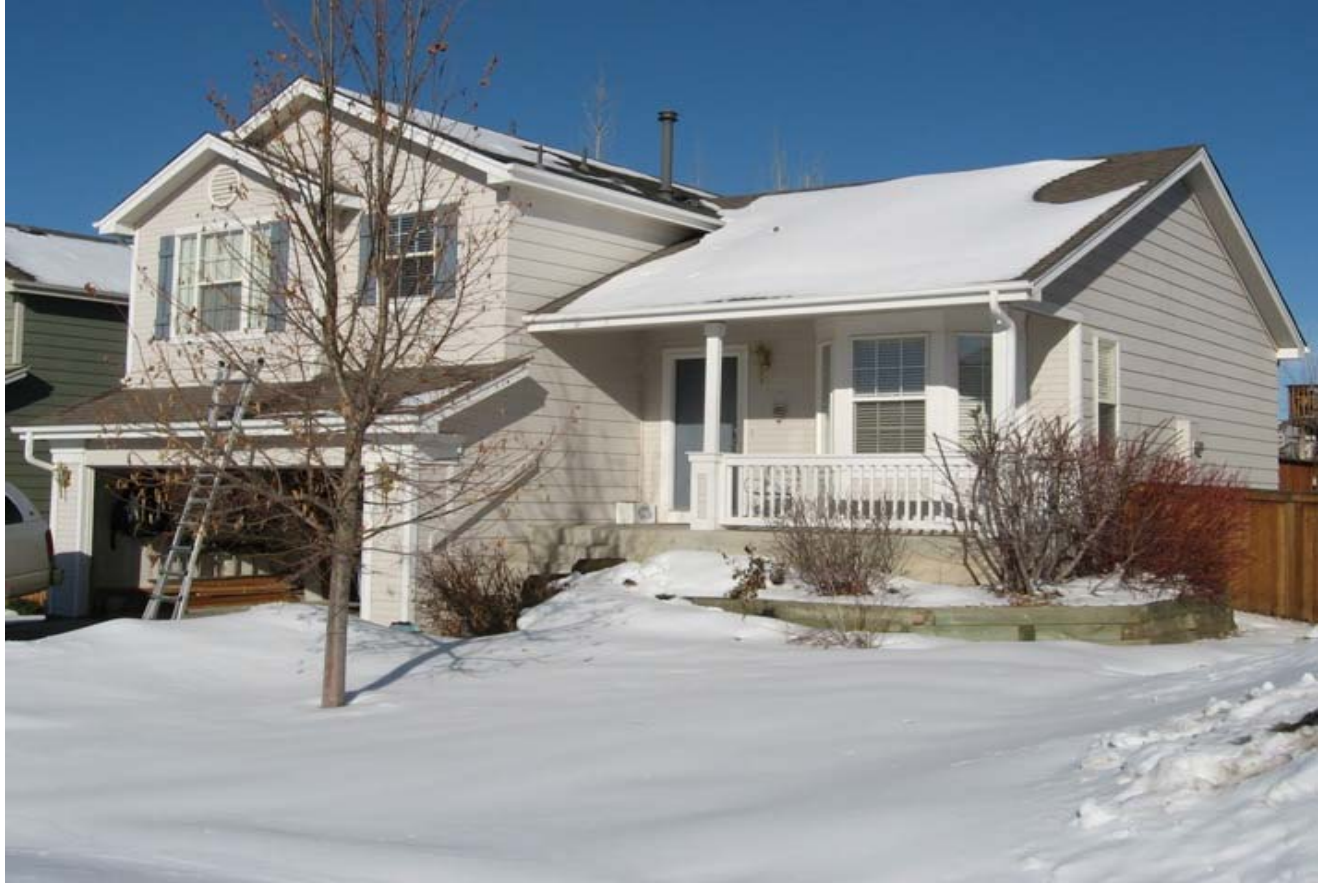
Main Entry Faces South.

Building Type	single family res.; tri-level; crawl space.
Garage	attached; tuckunder.
Area in Square Feet	1452
Street	through; paved.
Weather Conditions	clear. 48 degrees.
Starting Time	10:00; a.m..
Estimated Age	1999
Water Source	public.
Sewage Disposal	public.
Soil Conditions	wet; frozen; snow covered.
Occupied	yes; some furnishings present.
Present During Inspection	client's agent.

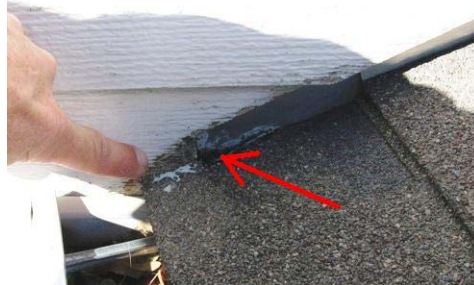
Component	Comments
Roof Visibility	Portions. Limited by snow and/or ice.
Method of Inspection	viewed from ground; viewed from gutter level.
Roof Design	gable.
Roofing Materials	composition shingles. The following conditions were noted: 1 layer. Some granular loss evident in gutters. From what was visible, 10+ years left on roofing material.
Flashings & Valleys	Due to snow/ice coverage, the roof was not fully inspected. Marginal. metal; woven shingles. Observed a missing kick-out flashing at gutter termination over entrance. Recommend adding kick-out flashing to prevent moisture from intruding behind siding. Caulking in this area should be kept in good repair to prevent water intrusion behind the siding.
Flue(s) for gas burner(s)	Functional. metal.

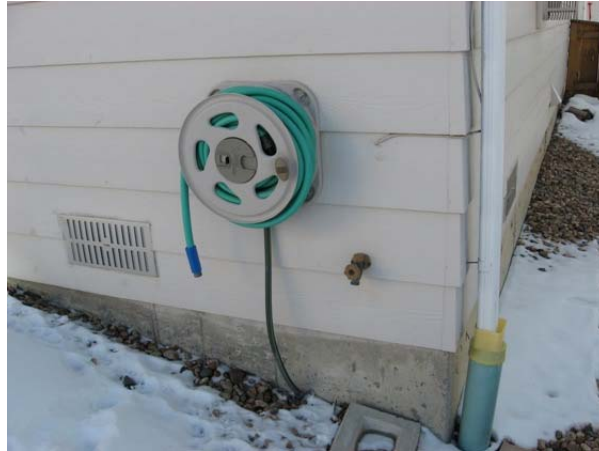
Downspout Drainage

buried drains. Buried drains are not recommended for our climate and soils. They can freeze and break in the colder months. They do not terminate onto the surface, in the warmer months water can back-up and overflow at the joints around the foundation. We recommend replacing with above ground extensions 5-6 feet long and drain away from the foundation walls.

*This picture also shows wall vents and a hose bibb. The hose bibb was not tested because of a valve turned off at the crawl-space. (see General Plumbing section) Wall vents should be open in warmer months and closed in the colder months.

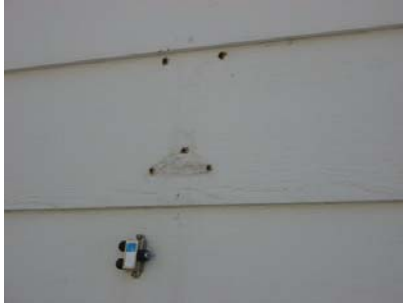
Component	Comments
Exterior Finish	<p>Marginal. hardboard siding. Seal all penetrations; nails, pipes, wiring, and others as needed. A dish was removed and the holes are not filled. Moisture can get behind the siding and inside the wall cavity at this area. Seal as needed.</p>

<p>Seal board ends and joints as needed.</p> <p>Some buckling due to board expansion noted on west side. This is caused by cutting the board too long at original construction.</p>

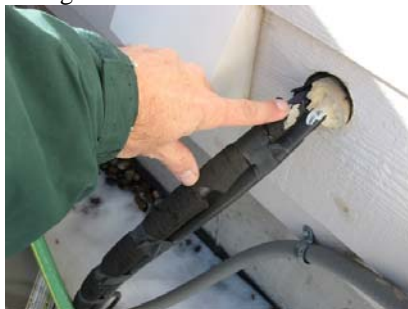
Ductwork and / or Heating pipes	Functional. ducts; sheet metal.
Humidifier	furnace mounted. This is considered an "accessory" to the heating system. It is not part of the inspection. We suggest that the system be checked by an HVAC technician to verify operation. The filter was dirty and should be replaced seasonally. A water shut off was present. To prevent damaging ducts and the heat exchanger of the furnace, the humidifier should only be used in the months the furnace is in operation.
Thermostat(s)	Functional. programmable; heating; cooling.
Manufacturer (cooling)	York.
Cooling System & Operation	electric; central. Exterior temperature below 60 degrees. Too cold to safely operate the system as operating it could harm the compressor (system not inspected). Unit not tested.
Compressor & Components	Marginal. Unit not tested.
	Refrigeration line at the exterior has insulation that needs repair or replacement.
